# Your Inspection Report

123 Main Street  
McAllen, TX 78504

**INSPECTION DATE:**  
Wednesday, February 24, 2016

RE: Report No. 1001, v.0  
123 Main Street  
McAllen, TX  
78504

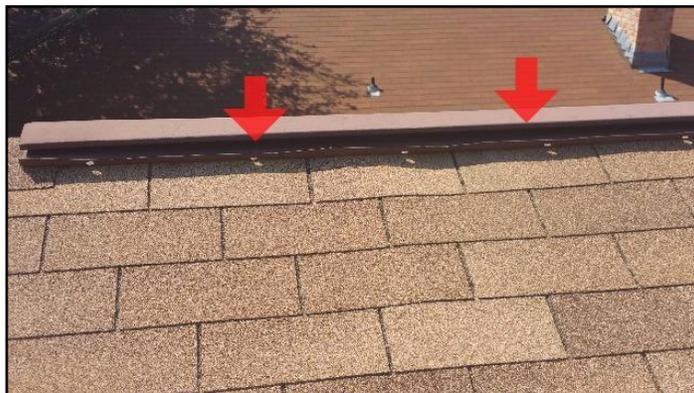
1. *Composition shingles*

- [Asphalt shingles](#)
- Composition shingles

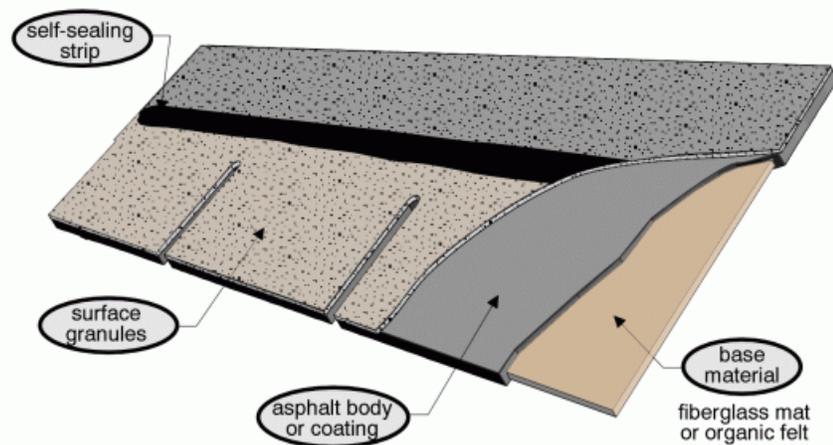
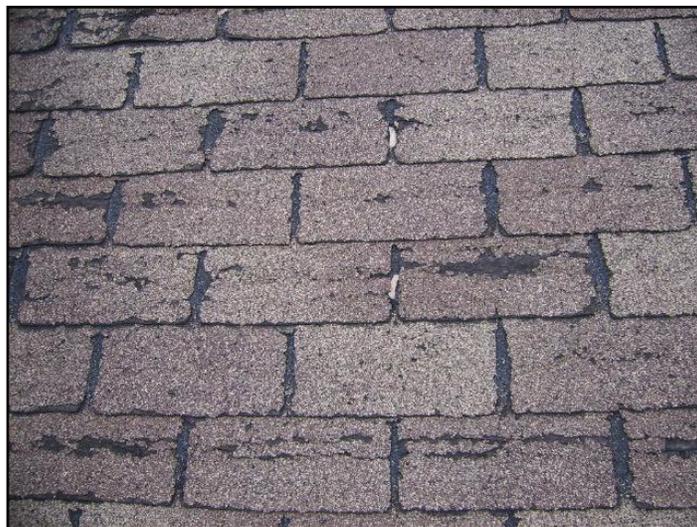
2.

1. **Condition:** • [Granule loss](#)

**Implication(s):** Chance of water damage to contents, finishes and/or structure

**Location:** South

## Asphalt shingle composition

**Task:** Replace

**Time:** Less than 1 year

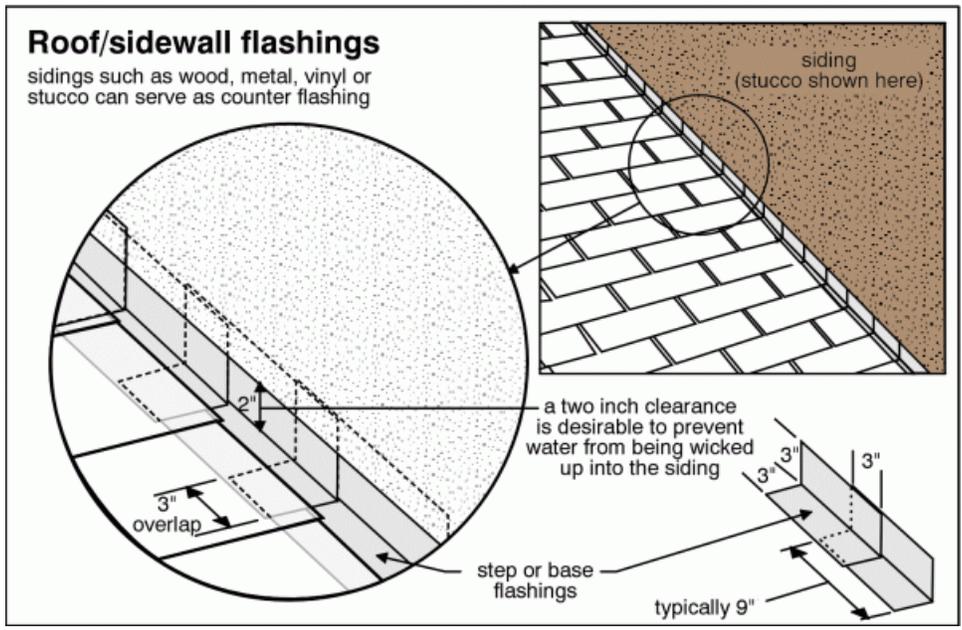
### **SLOPED ROOF FLASHINGS \ Roof/sidewall flashings**

**2. Condition:** • [No step or counter flashings](#)

**Implication(s):** Chance of water damage to contents, finishes and/or structure

**Task:** Further evaluation Service

**Time:** Immediate

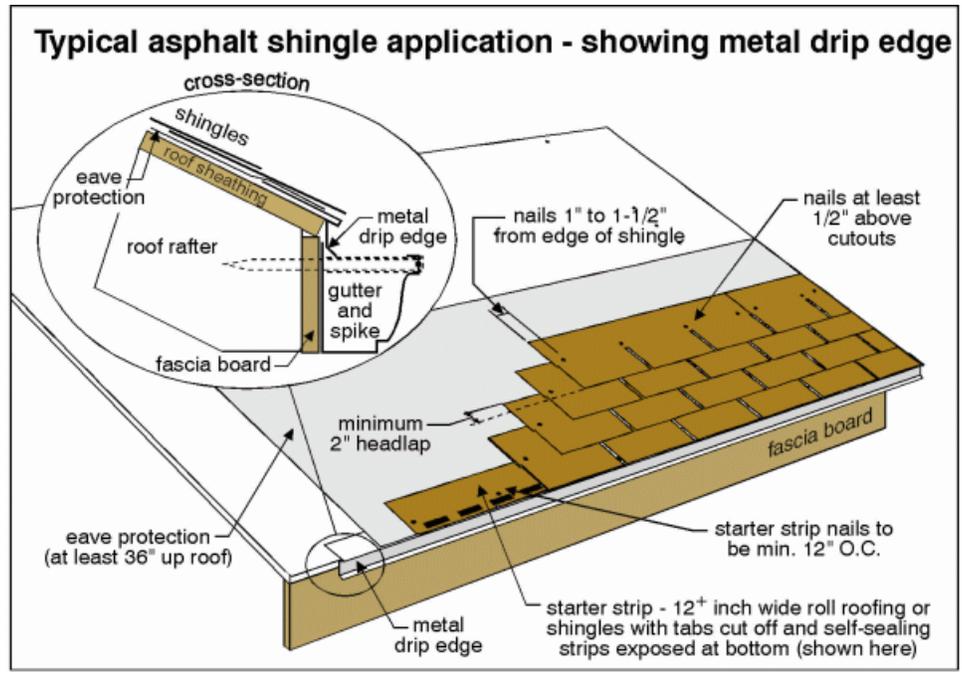
**SLOPED ROOF FLASHINGS \ Drip edge flashings**

3. Condition: • Missing

Implication(s): Chance of water damage to contents, finishes and/or structure

Task: Correct

Time: Less than 1 year

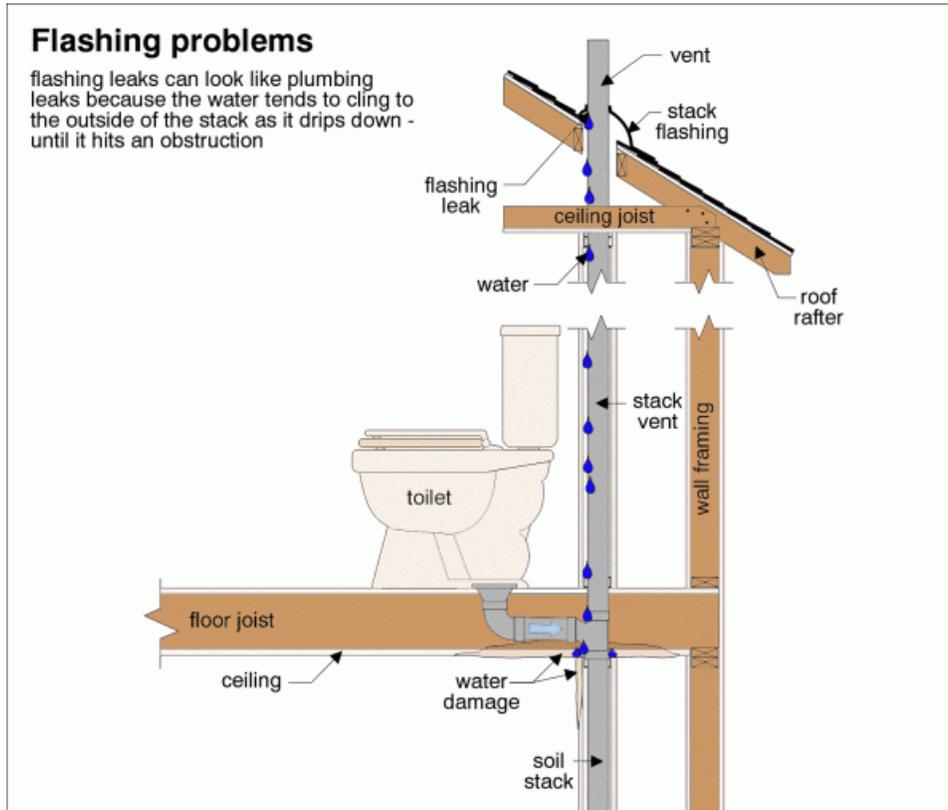
**SLOPED ROOF FLASHINGS \ Roof jacks**

4. Condition: • Installation poor

Implication(s): Chance of water damage to contents, finishes and/or structure

**Task:** Correct

**Time:** Less than 1 year
